**FORD:**

2014-2015 Transit Connect

This article supersedes TSB **14-0181** to update the vehicle model years.

**ISSUE**

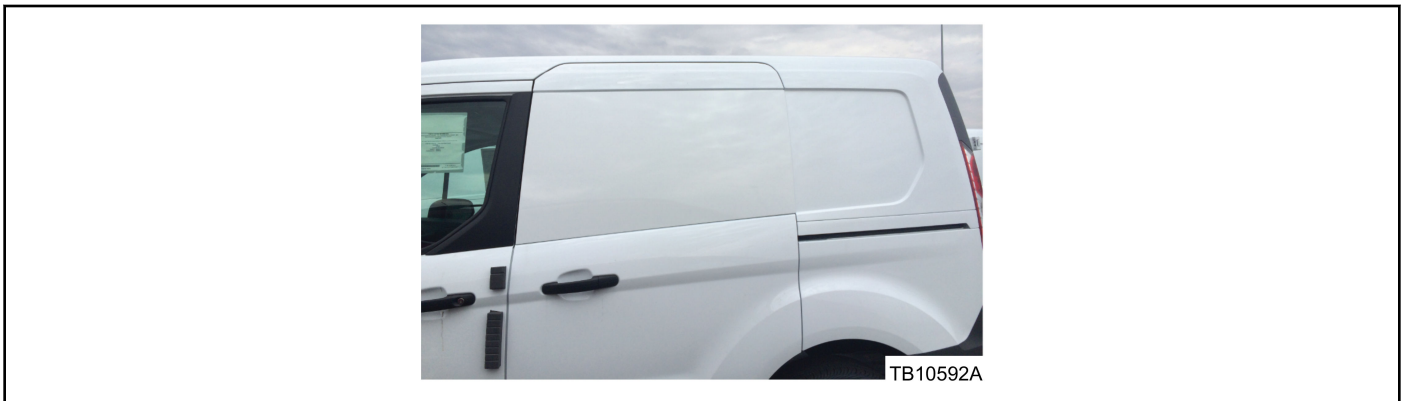
Figure 1 - Article 15-0085

Some 2014-2015 Transit Connect vehicles equipped with sliding door blanking panels may exhibit small scratches on the sliding door body panel, where the blanking panel meets the body panel. These scratches may be located on either door and anywhere around the blanking panel top, bottom or sides. The scratches may have broken through the paint to expose bare metal.

1. Are paint scratches present on the exterior of the left or right sliding doors near the blanking panels? (Figure 1)

- a. Yes - proceed to Step 2.
  - b. No - this article does not apply.
2. Remove the blanking panel. Refer to Workshop Manual (WSM), Section 501-11 General Procedures.
    - a. Blanking panel is removed in the same manner as fixed glass.
  3. Repair any scratches around and under the sliding door blanking panel, specifically those located outside the urethane bead and potentially exposed to weather (rain and humidity). (Figures 2-3)
